Humidifier on the wrong limb of the Servo-i

Watch Out Notice: 04 Date: 19 Dec 2013 Produced By: Critical Care Governance Group Author: N Tarmey

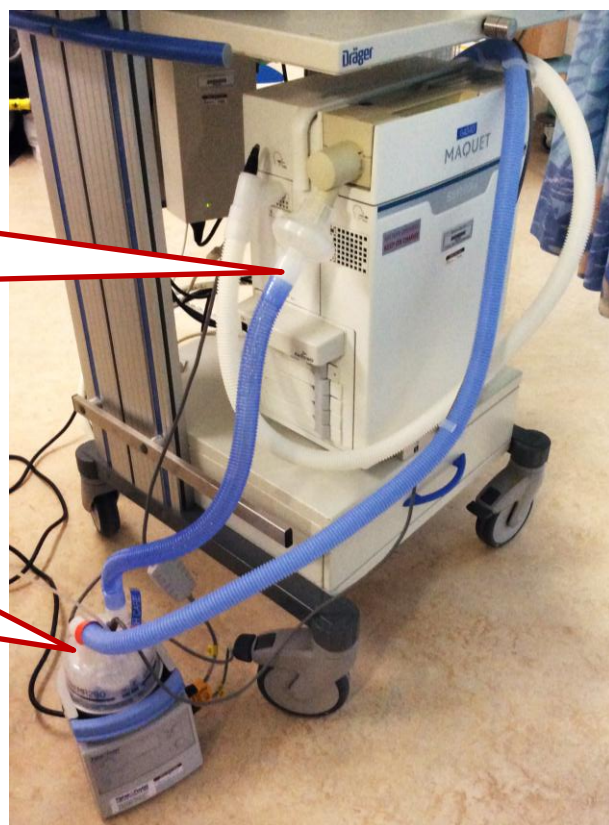
A patient in ICU was ventilated using the Servo-i, with the humidifier accidentally installed on the expiratory limb.

Initially the system seemed to work, but it then failed completely and the ventilator had to be swapped for a new machine.

- The humidifier must be installed on the **inspiratory** limb of the circuit for the Servo-i.
- Installing the humidifier on the wrong limb can cause ventilator failure and dangerous levels of PEEP to the patient.

- Always check the humidifier is installed on the inspiratory limb.
- If your patient's ventilation is getting worse, remember it could be an equipment problem.
